CHARLES RIVER BASIN
MILFORD, MASSACHUSETTS

CEDAR SWAMP POND DAM
MA 00628

PHASE I INSPECTION REPORT
NATIONAL DAM INSPECTION PROGRAM

Date of Inspection: June 14, 1978

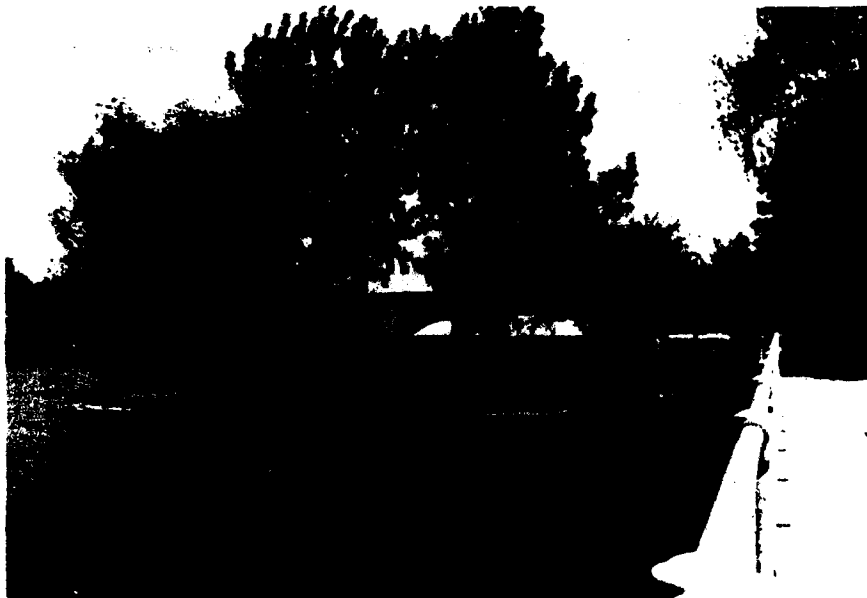
NO. 1 - VIEW OF EAST ABUTMENT, UPSTREAM AREA

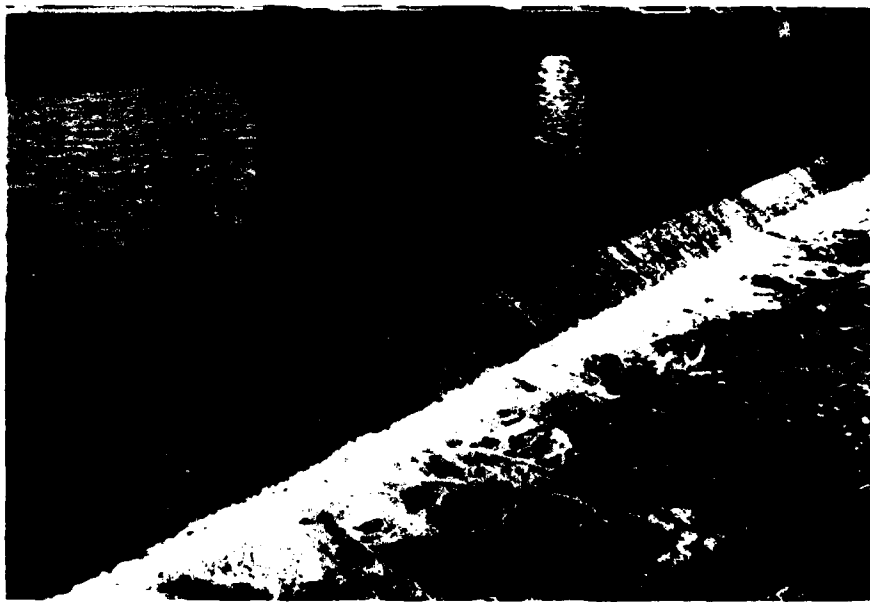
- c. Visual Observations. The concrete ogee spillway for Cedar Swamp Pond is ungated and flow is unrestricted. Eleven (11) inch removable flashboards are in place along the dam crest. However, the access plates to the flashboards are welded shut and the flashboards cannot easily be removed. Also the eye bolts for the flashboards are missing. The general condition of the spillway is good except for some minor concrete spalling.

* flashboards in place on top of spillway crest - 10" high, wooden - missing eye bolts for removal - plates for access on deck surface are welded shut.

**NO. 3 - DETAIL OF SPILLWAY WEIR SHOWING
FLASHBOARDS AND CONCRETE PIERS**

- (5) reopen access plates to flashboards and shut using bolts only;
 - (6) install eyebolts on flashboards;
 - (7) implement a systematic program of inspection and maintenance. As a minimum, the inspection program should consist of a monthly inspection of the dam and appurtenances and should be supplemented by additional inspections during and after severe storms. Operation of the slide gates should also be checked at least twice a year. All repairs and maintenance should be undertaken in accordance with all applicable State regulations.

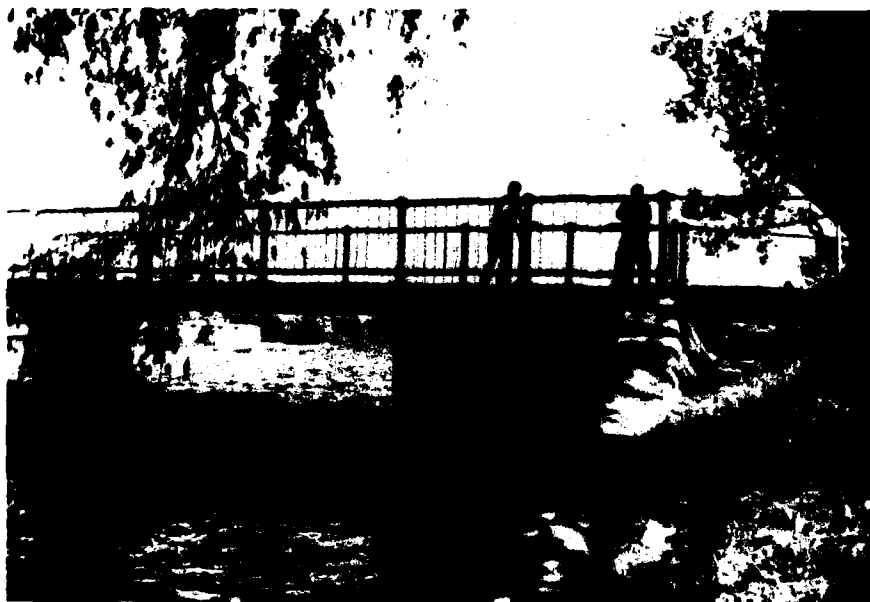
**NO. 4 - VIEW OF EAST ABUTMENT, DOWNSTREAM
FACE, WITH SLIDE GATES IN CENTER OF PICTURE**
